WELL-INTEGRITY SURVEY (PHASE II) OF ABANDONED HOMESTEAD WATER WELLS IN THE HIGH PLAINS AQUIFER, FORMER PANTECH ORDNANCE PLANT AND TEXAS TECH RESEARCH FARM NEAR AMARILLO, TEXAS, 1995

U.S. GEOLOGICAL SURVEY
Open-File Report 95-751

Prepared in cooperation with the
U.S. ARMY CORPS OF ENGINEERS,
TULSA DISTRICT

By Glenn A. Rivers

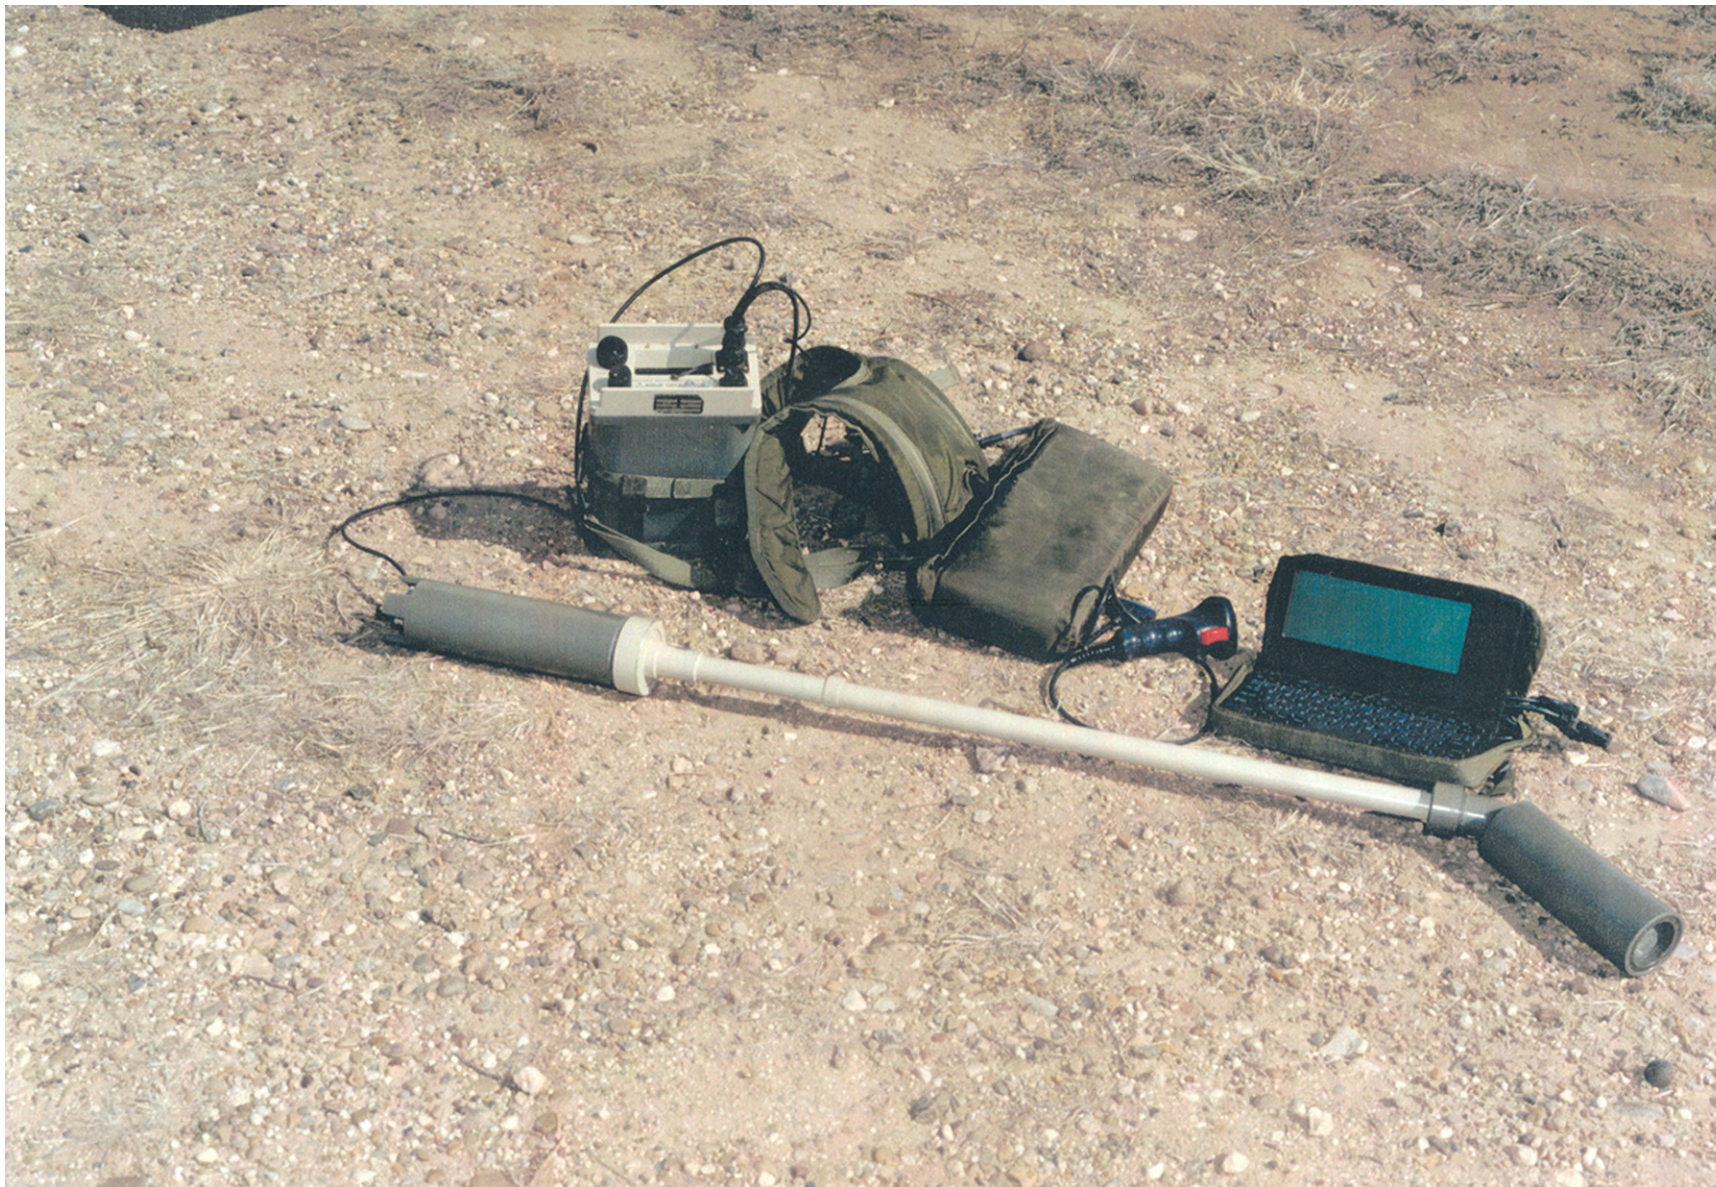
Figure 3. Cesium magnetometer and palmtop computer used during well-integrity survey (phase II), former Pantex Ordnance Plant and Texas Tech Research Farm near Amarillo, Texas. Photograph by John S. Ebling.

After locating the potential abandoned homestead sites, the next step in the search for water wells involved sweeping, or scanning, each of the 18 sites using a cesium magnetometer (fig. 3). The cesium magnetometer is an

instrument designed to detect changes in the earth's magnetic field (Breiner, 1973). Spatial variations, or anomalies, in the earth's magnetic field can be caused by induced magnetism; for example, a water-well casing constructed of iron alloys will produce a local magnetic anomaly that is substantially greater than the earth's ambient (background) magnetic field.

Cesium magnetometer scans, near the abandoned homestead sites, measured an ambient magnetic field of $52,300 \pm 300$ gammas for the Pantex site. A monitoring well at known homestead site HL-19 was used to determine the instrument response to a water well. The magnetic anomaly caused by the well was $28,000 \pm 500$ gammas more than the ambient magnetic field. The field crew returned to HL-19 periodically to verify that the magnetometer was operating properly.

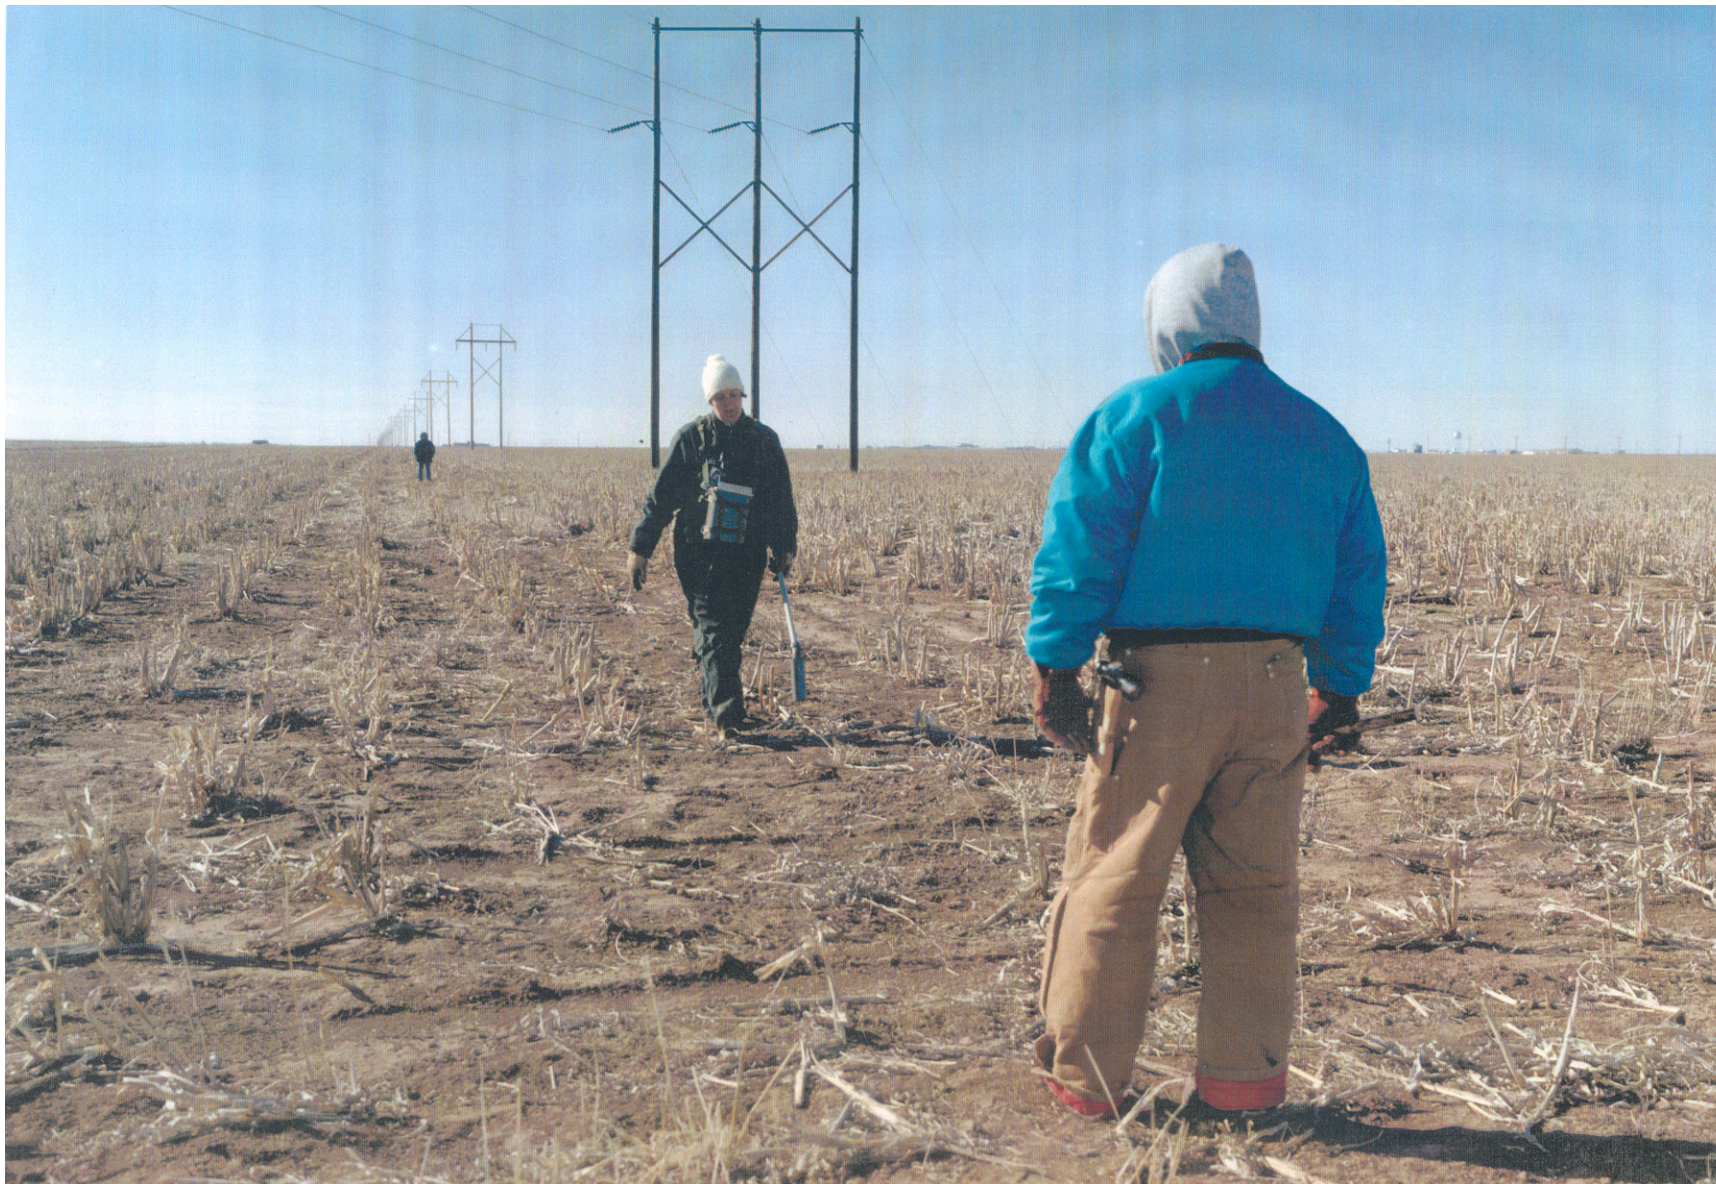
Figure 4. Magnetometer sweep at homestead site HL-4, former Pantex Ordnance Plant and Texas Tech Research Farm near Amarillo, Texas. Photograph by John S. Ebling.

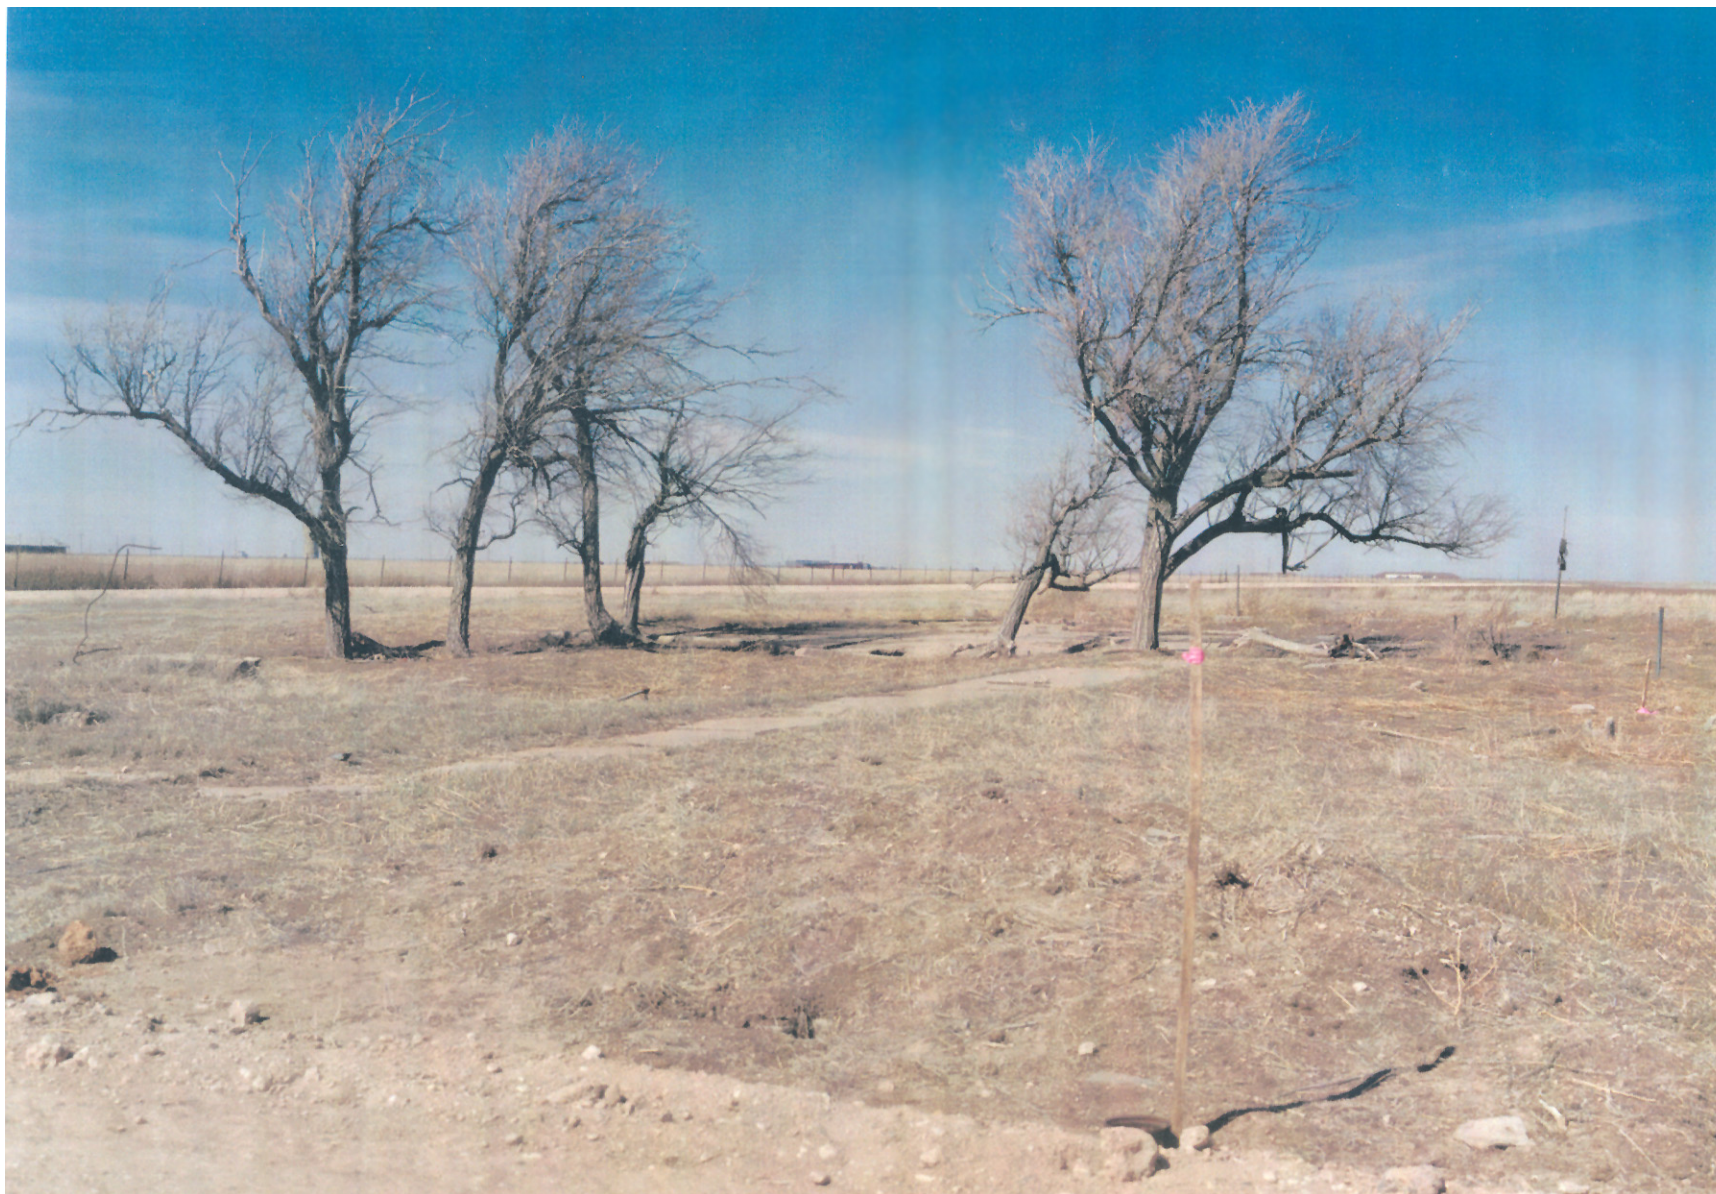
Figure 5. Staked and flagged anomaly (well) at homestead site HL-11, former Pantex Ordnance Plant and Texas Tech Research Farm near Amarillo, Texas. Photograph by John S. Ebling.

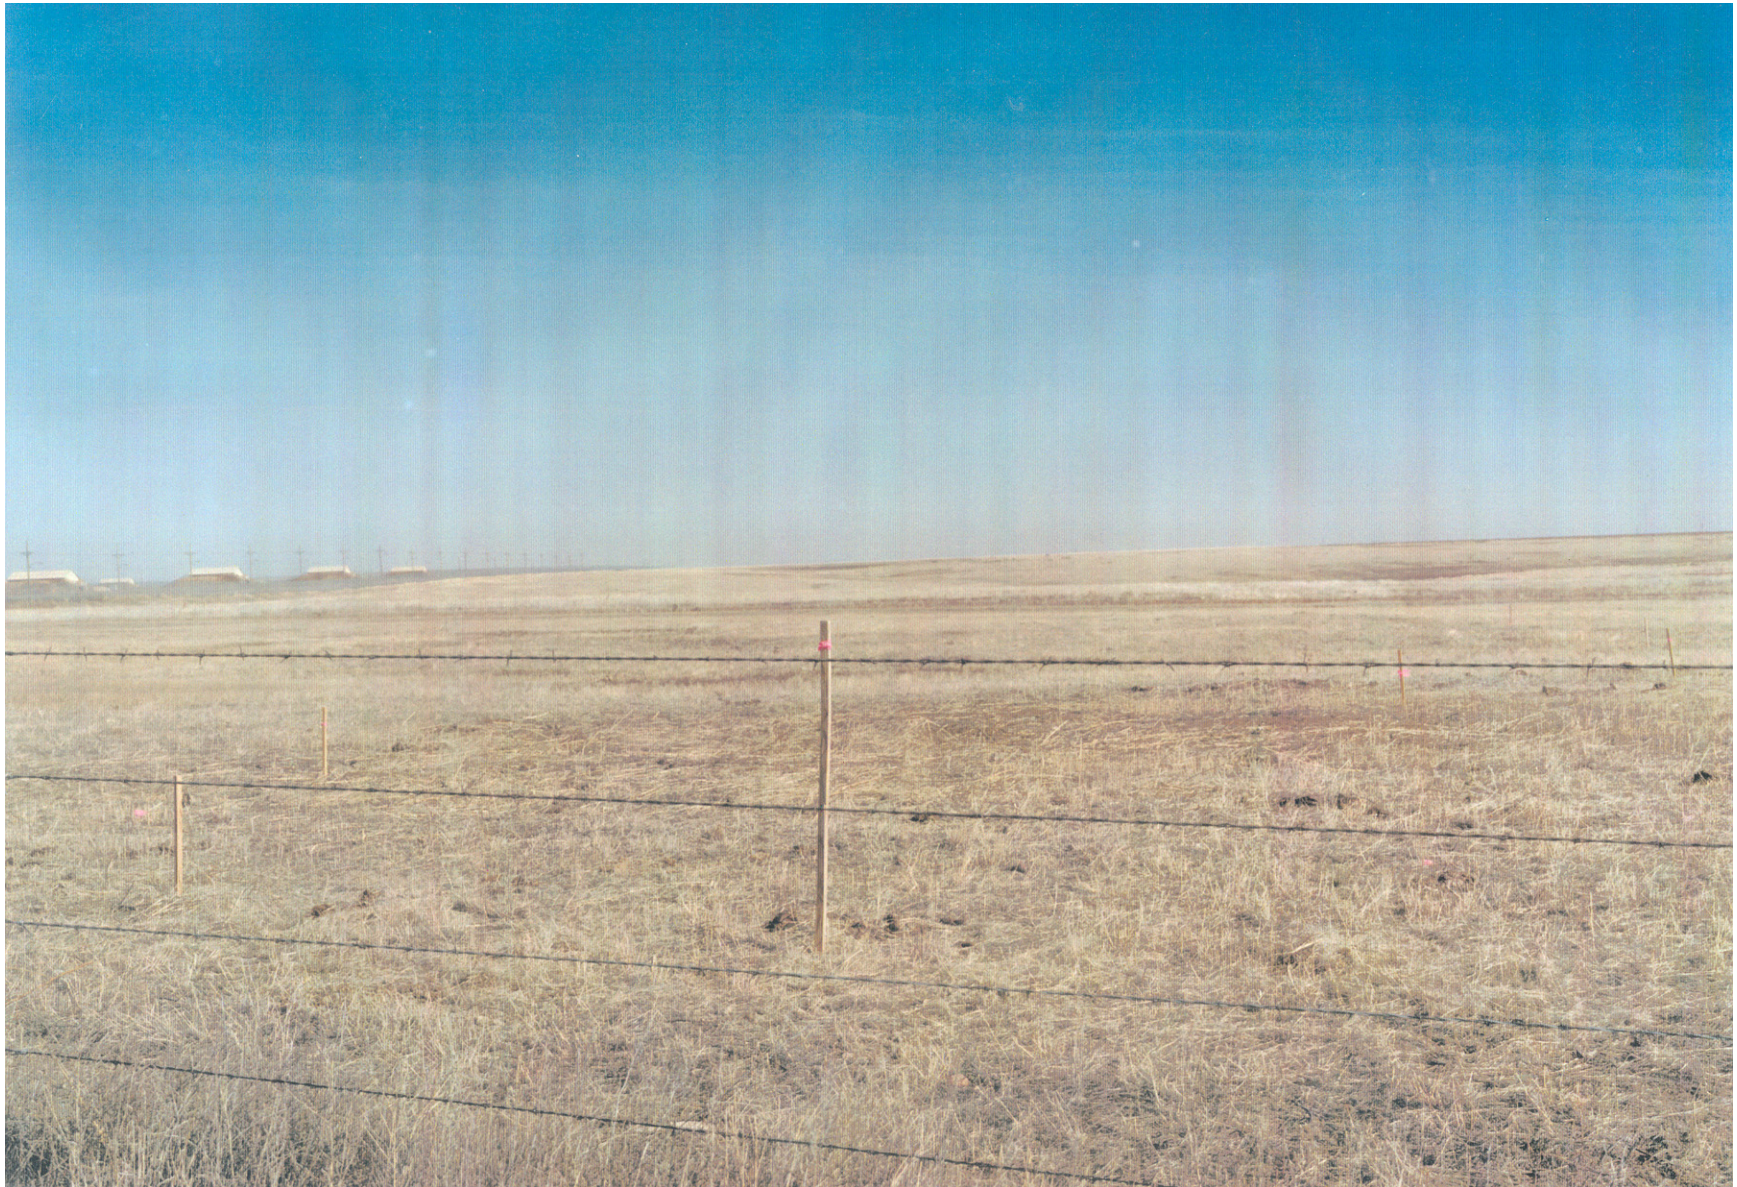
Figure 6. Mapping grid at homestead site HL-16, former Pantex Ordnance Plant and Texas Tech Research Farm near Amarillo, Texas. Photograph by John S. Ebling.

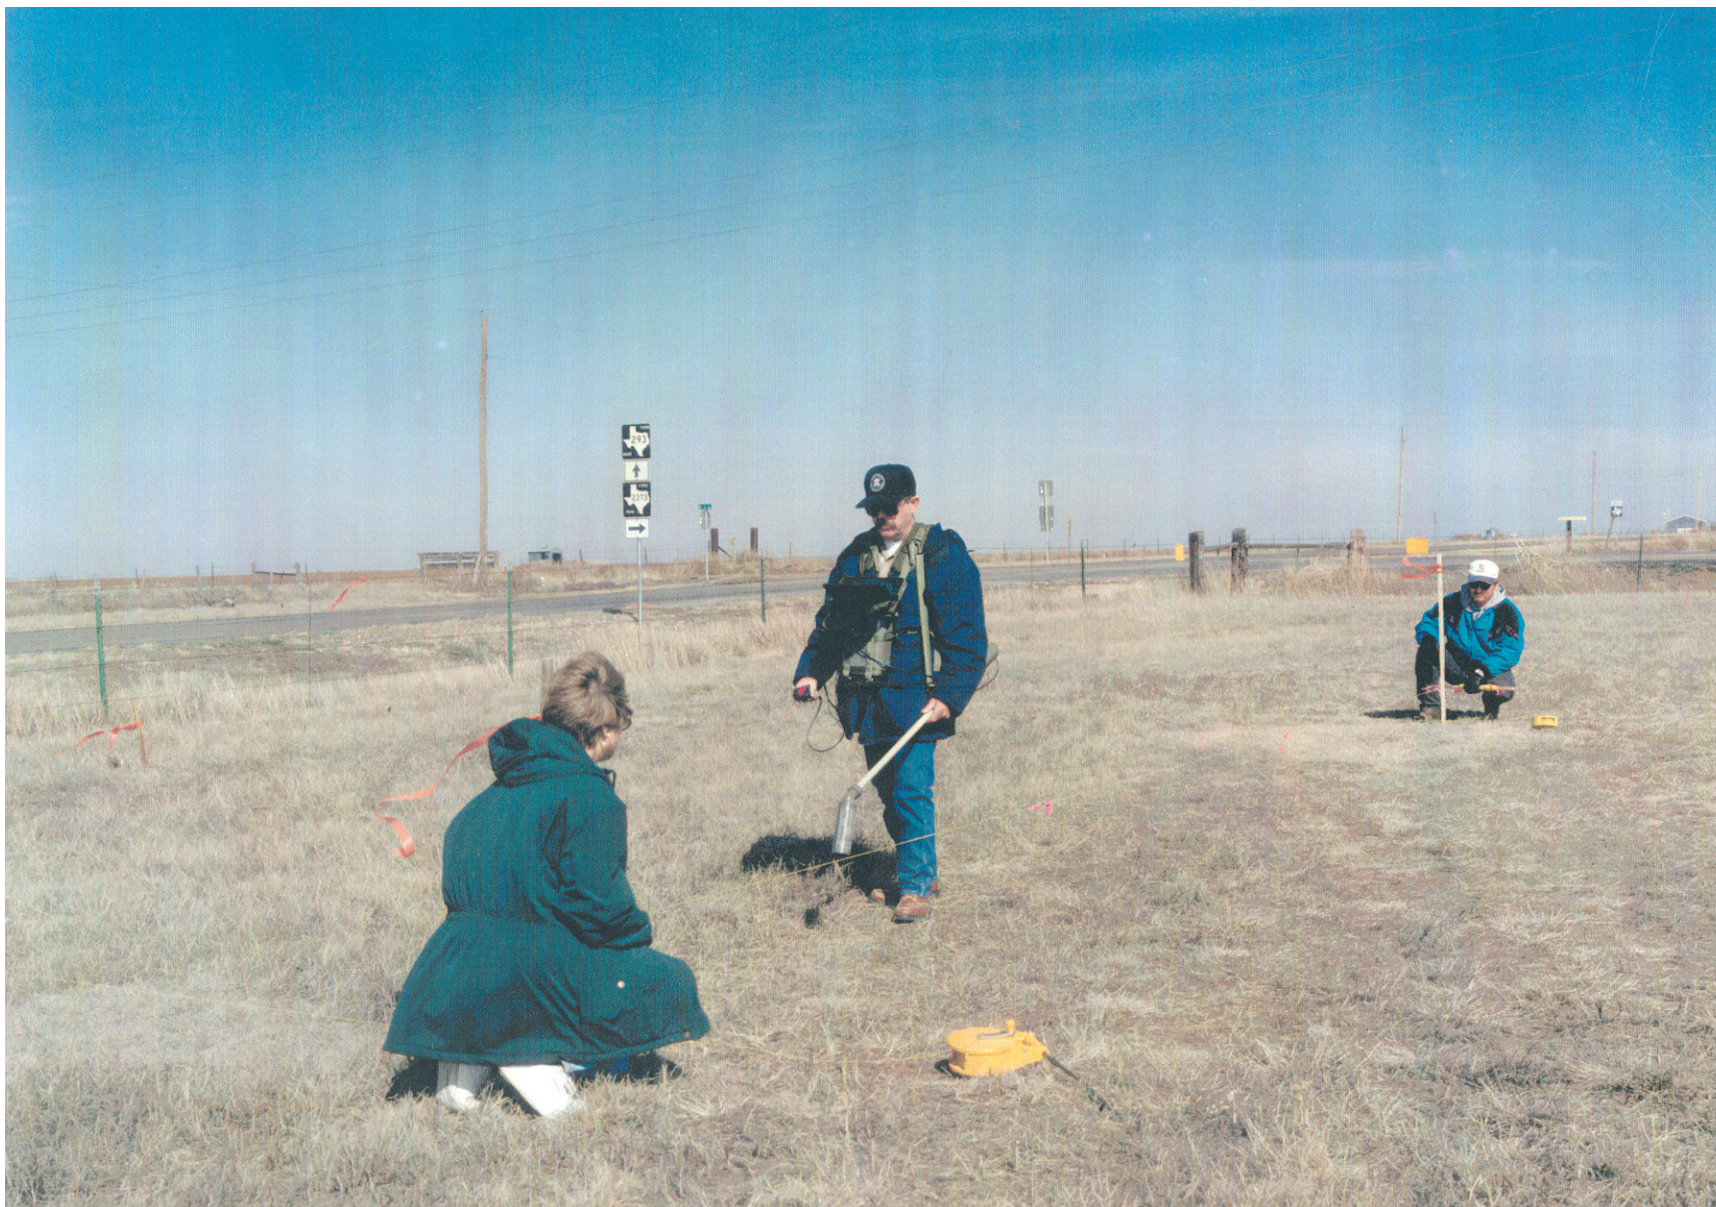
Figure 7. Magnetometer mapping survey at homestead site HL-4, former Pantex Ordnance Plant and Texas Tech Research Farm near Amarillo, Texas. Photograph by John S. Ebling.

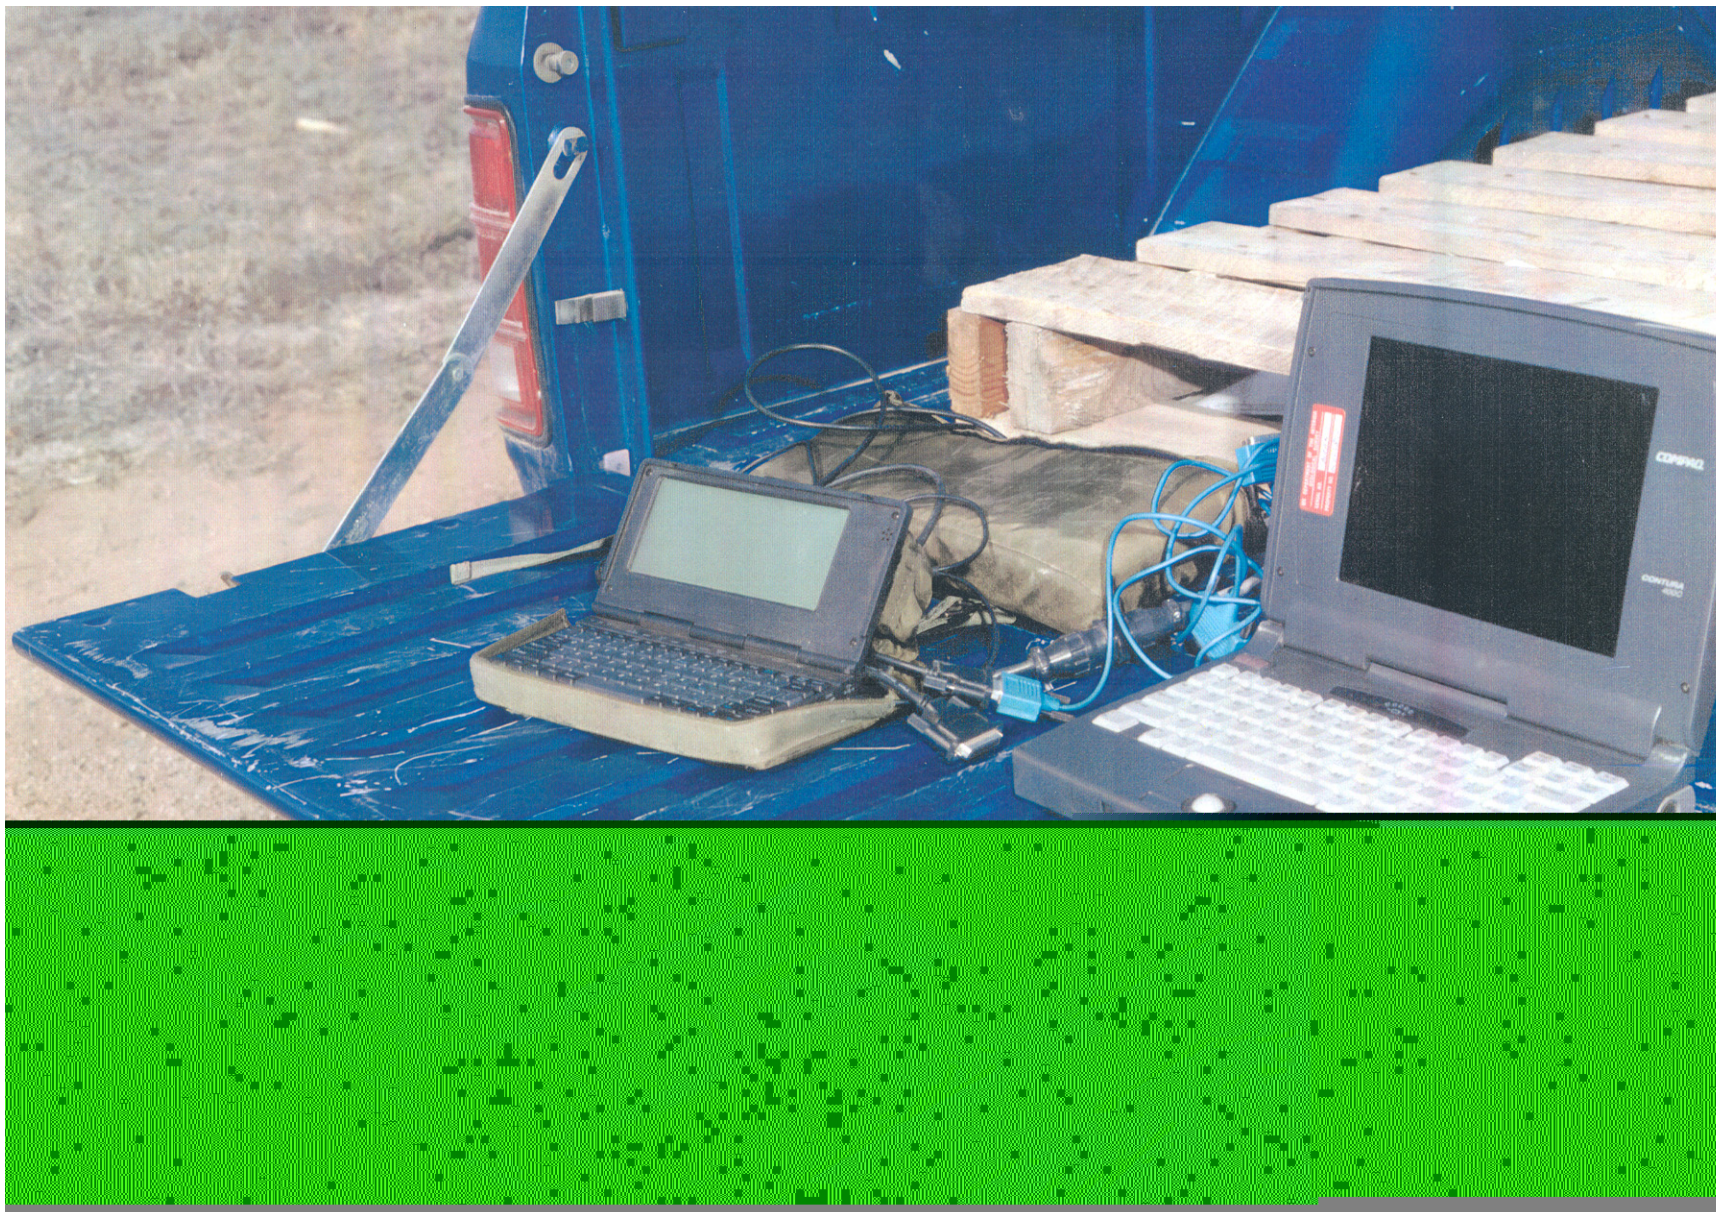
Figure 8. Downloading survey data from palmtop computer to personal computer. Photograph by John S. Ebling.

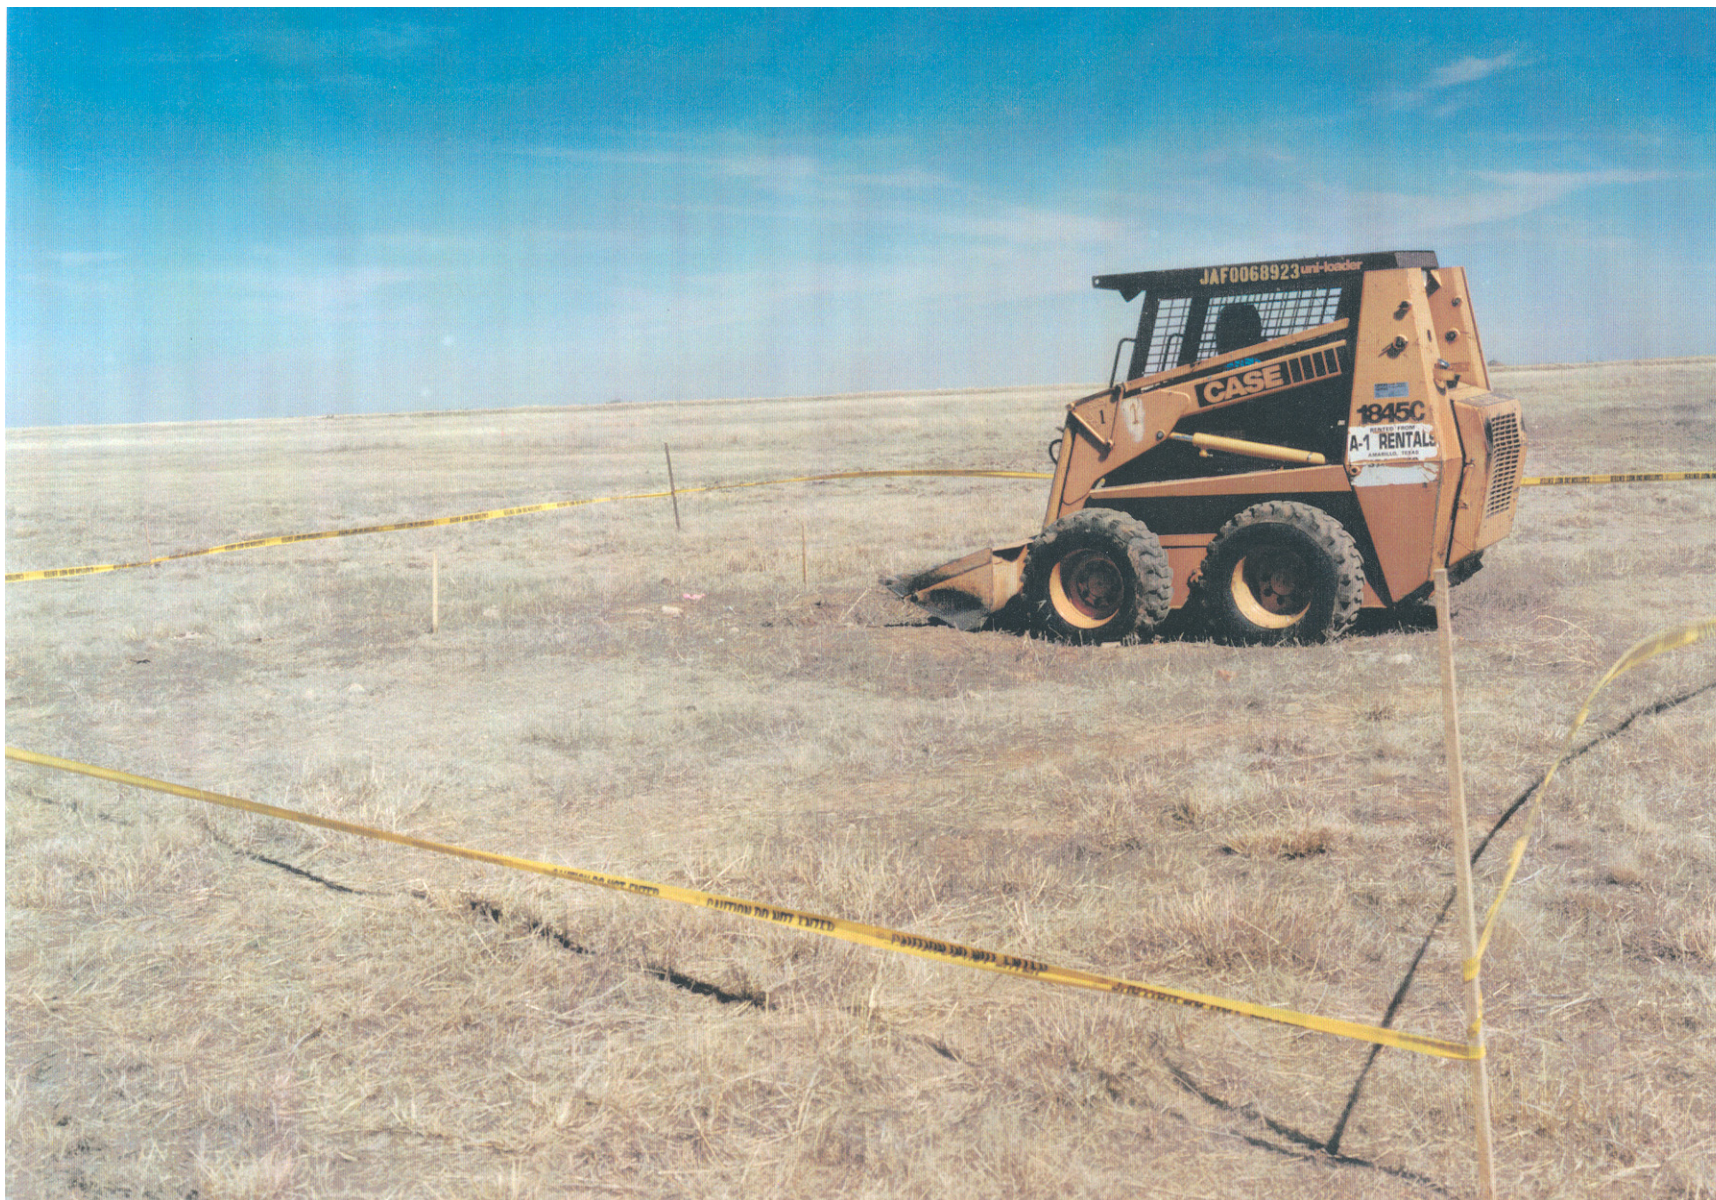
Figure 9. Case uni-loader used during well-integrity survey (phase II), former Pantex Ordnance Plant and Texas Tech Research Farm near Amarillo, Texas. Photograph by John S. Ebling.

The excavation process involved removing the soil with a Case uni-loader (fig. 9); identifying and removing, where possible, the source of the magnetic anomaly; verifying that the source had been removed by sweeping the excavated area with the magnetometer; and then returning soil to the excavated site. The maximum magnetic anomalies at the homestead sites and the objects that were excavated are listed in table 2. Appendices 2 and 3 show photographs of several abandoned homestead sites before and after excavation.

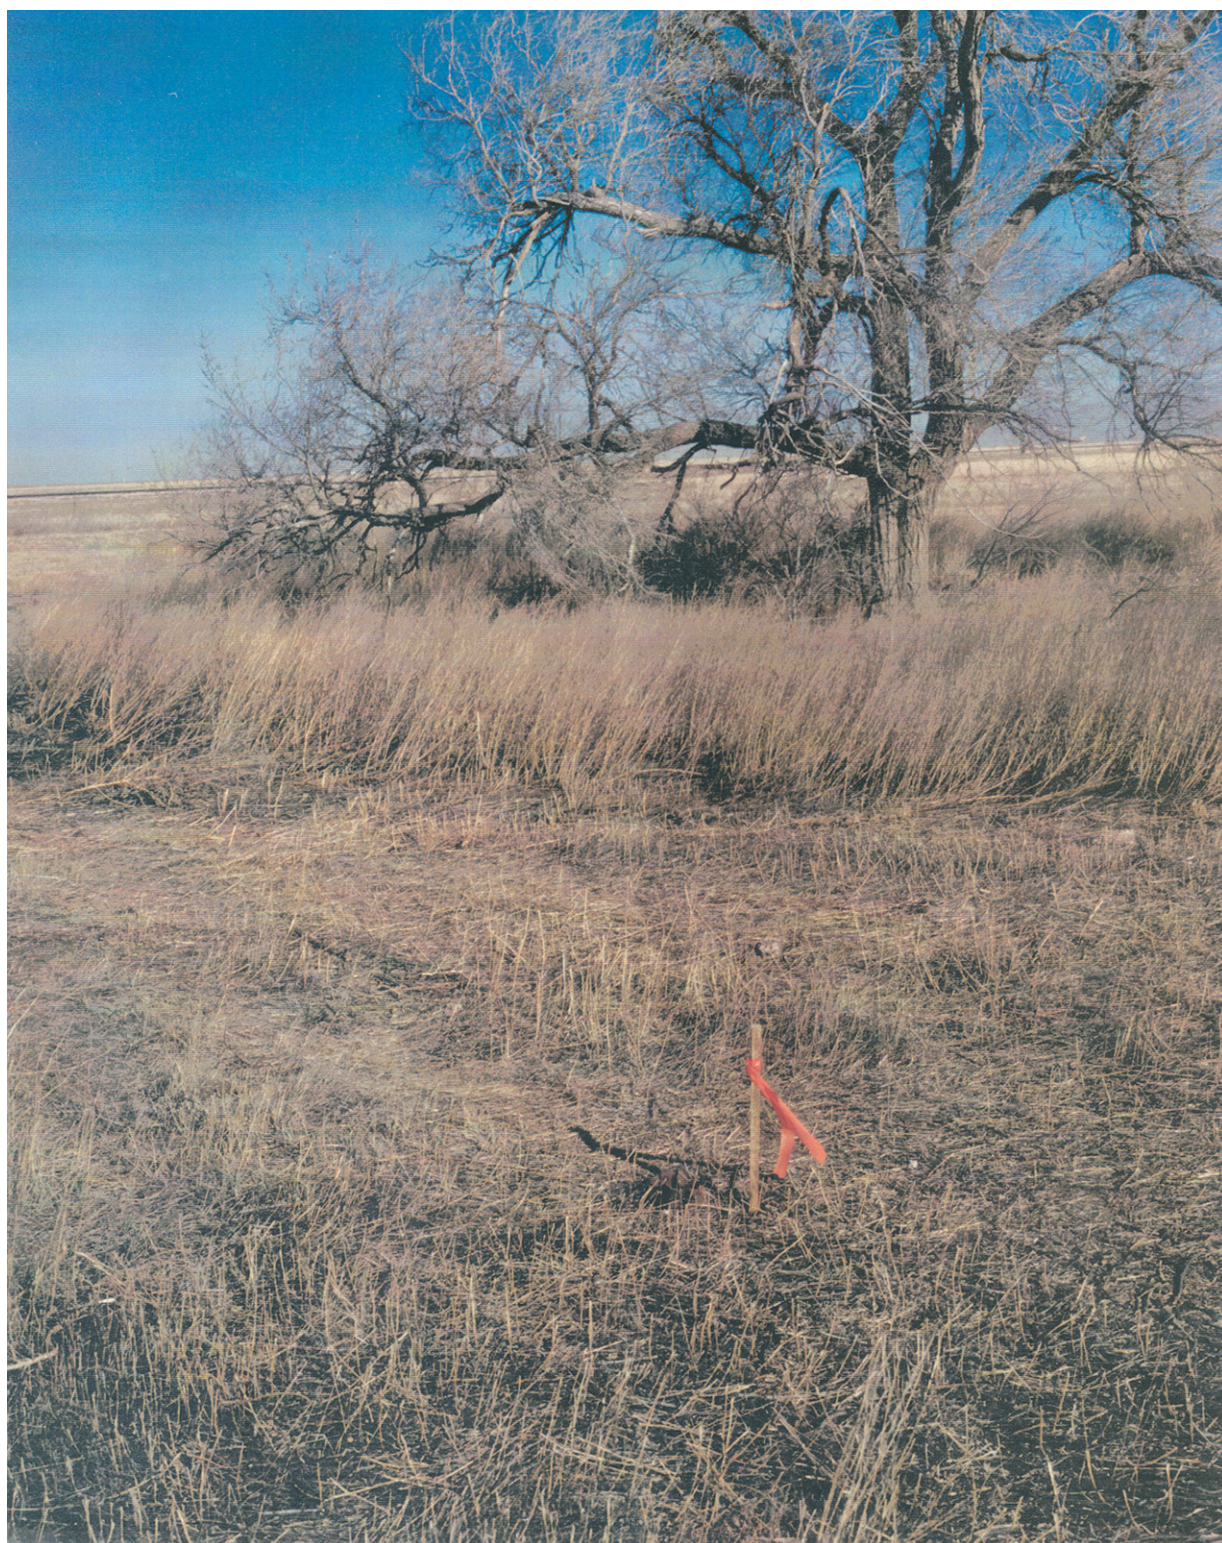
The remains of eight water wells were located at seven abandoned homestead sites (table 4)—HL-3, HL-4, HL-5, HL-9 (two wells), HL-10 (fig. 10), HL-11 (fig. 11), and HL-17 (fig. 12). Three of the eight wells (HL-4, HL-5, and HL-17) can be accessed using a steel tape. The three wells were measured with a 300-ft steel tape; water levels were not detected in any of these wells. HL-4 and HL-5 are accessible to more than 297 ft below land surface; HL-17 is accessible to 277.8 ft below land surface, which is less than the reported depth of 348 ft (reported well depths in table 4 are from the well-completion data obtained during the phase I records search). Five of the eight wells—HL-3, HL-9 (both wells), HL-10, and HL-11—are inaccessible to steel-tape measurement. HL-3 and

Figure 10. Well at homestead site HL-10, former Pantex Ordnance Plant and Texas Tech Research Farm near Amarillo, Texas. Photograph by John S. Ebling.

Tops of well casings were found at or above land surface at four abandoned homestead sites. The top of the casing at HL-4 is at land surface. The tops of casings at HL-10 (fig. 10), HL-11 (fig. 11), and HL-17 (fig. 12) are above land surface. Excavations at HL-3, HL-5 (fig. 13), and HL-9 exposed tops of well casings that had been pushed over and buried to about 18 in. below land surface.

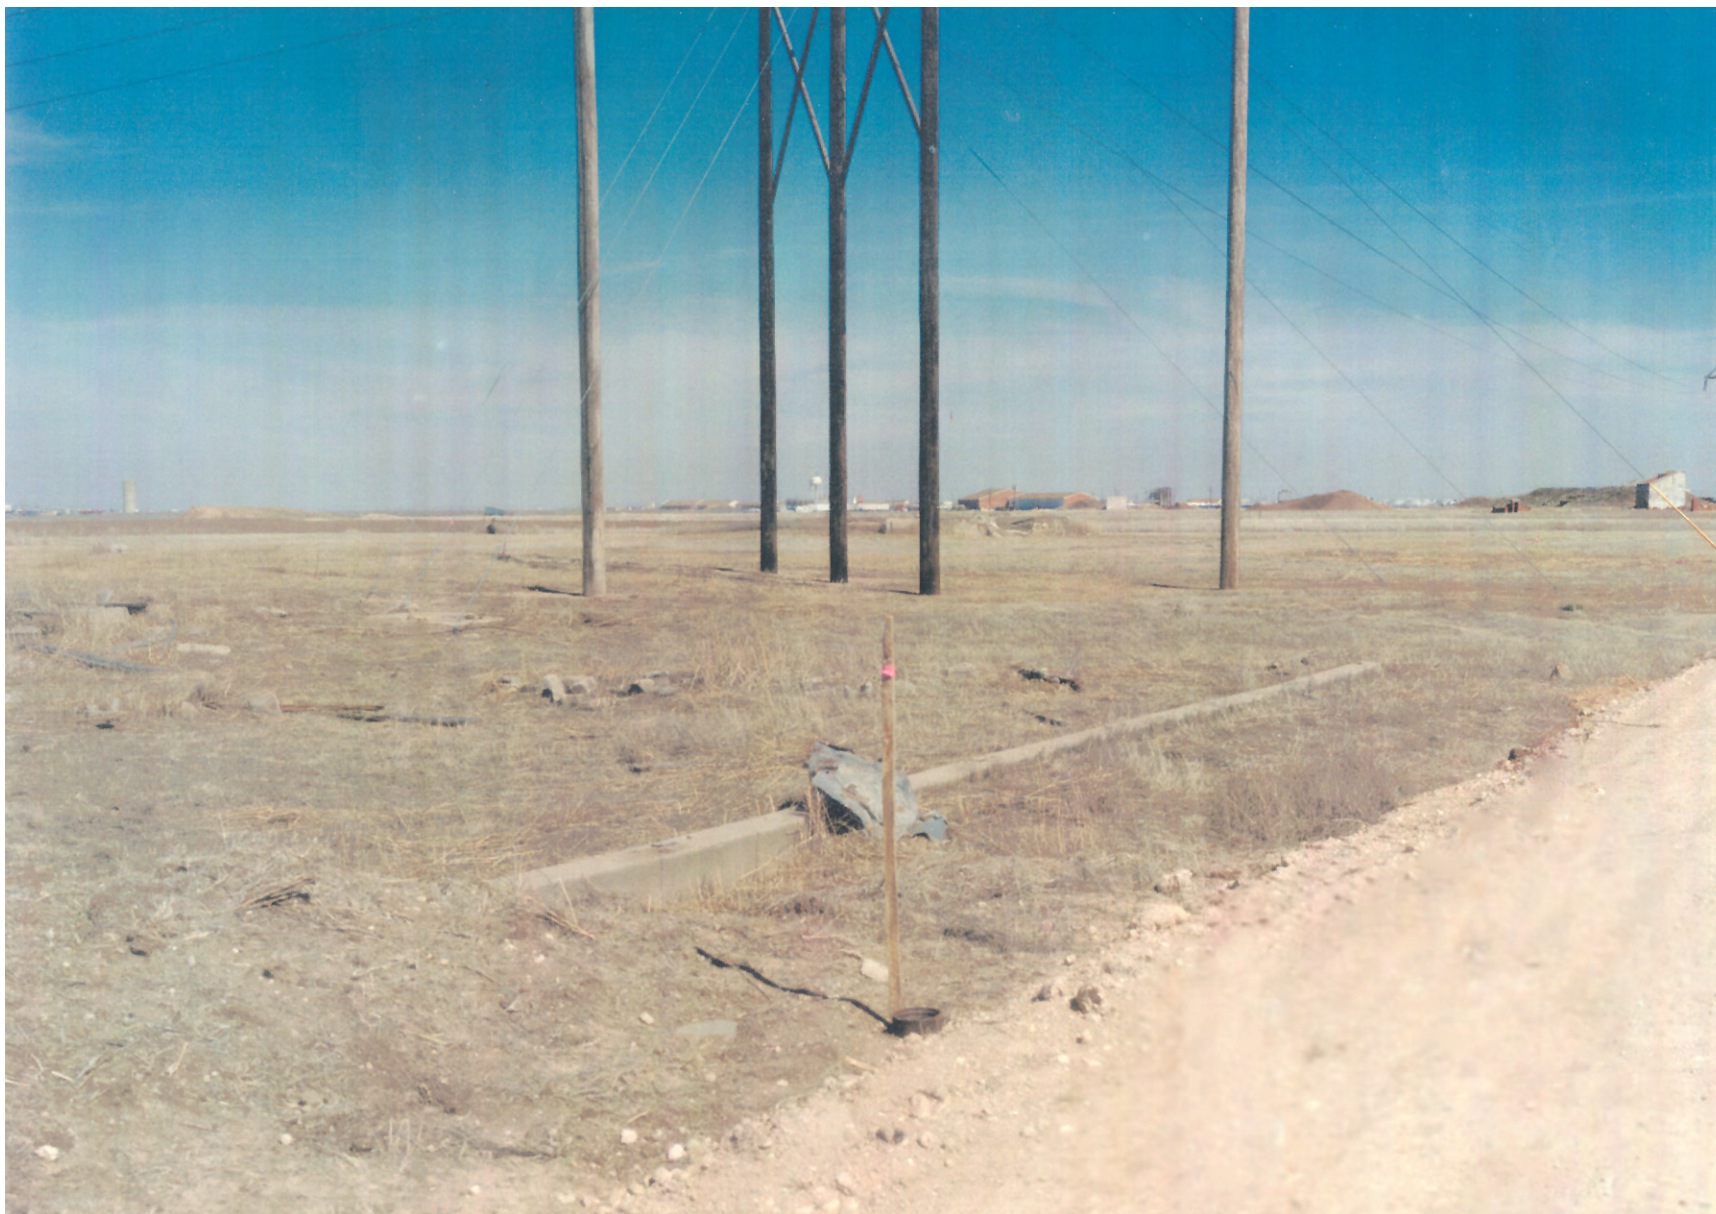
Figure 11. Well at homestead site HL-11, former Pantex Ordnance Plant and Texas Tech Research Farm near Amarillo, Texas. Photograph by John S. Ebling.

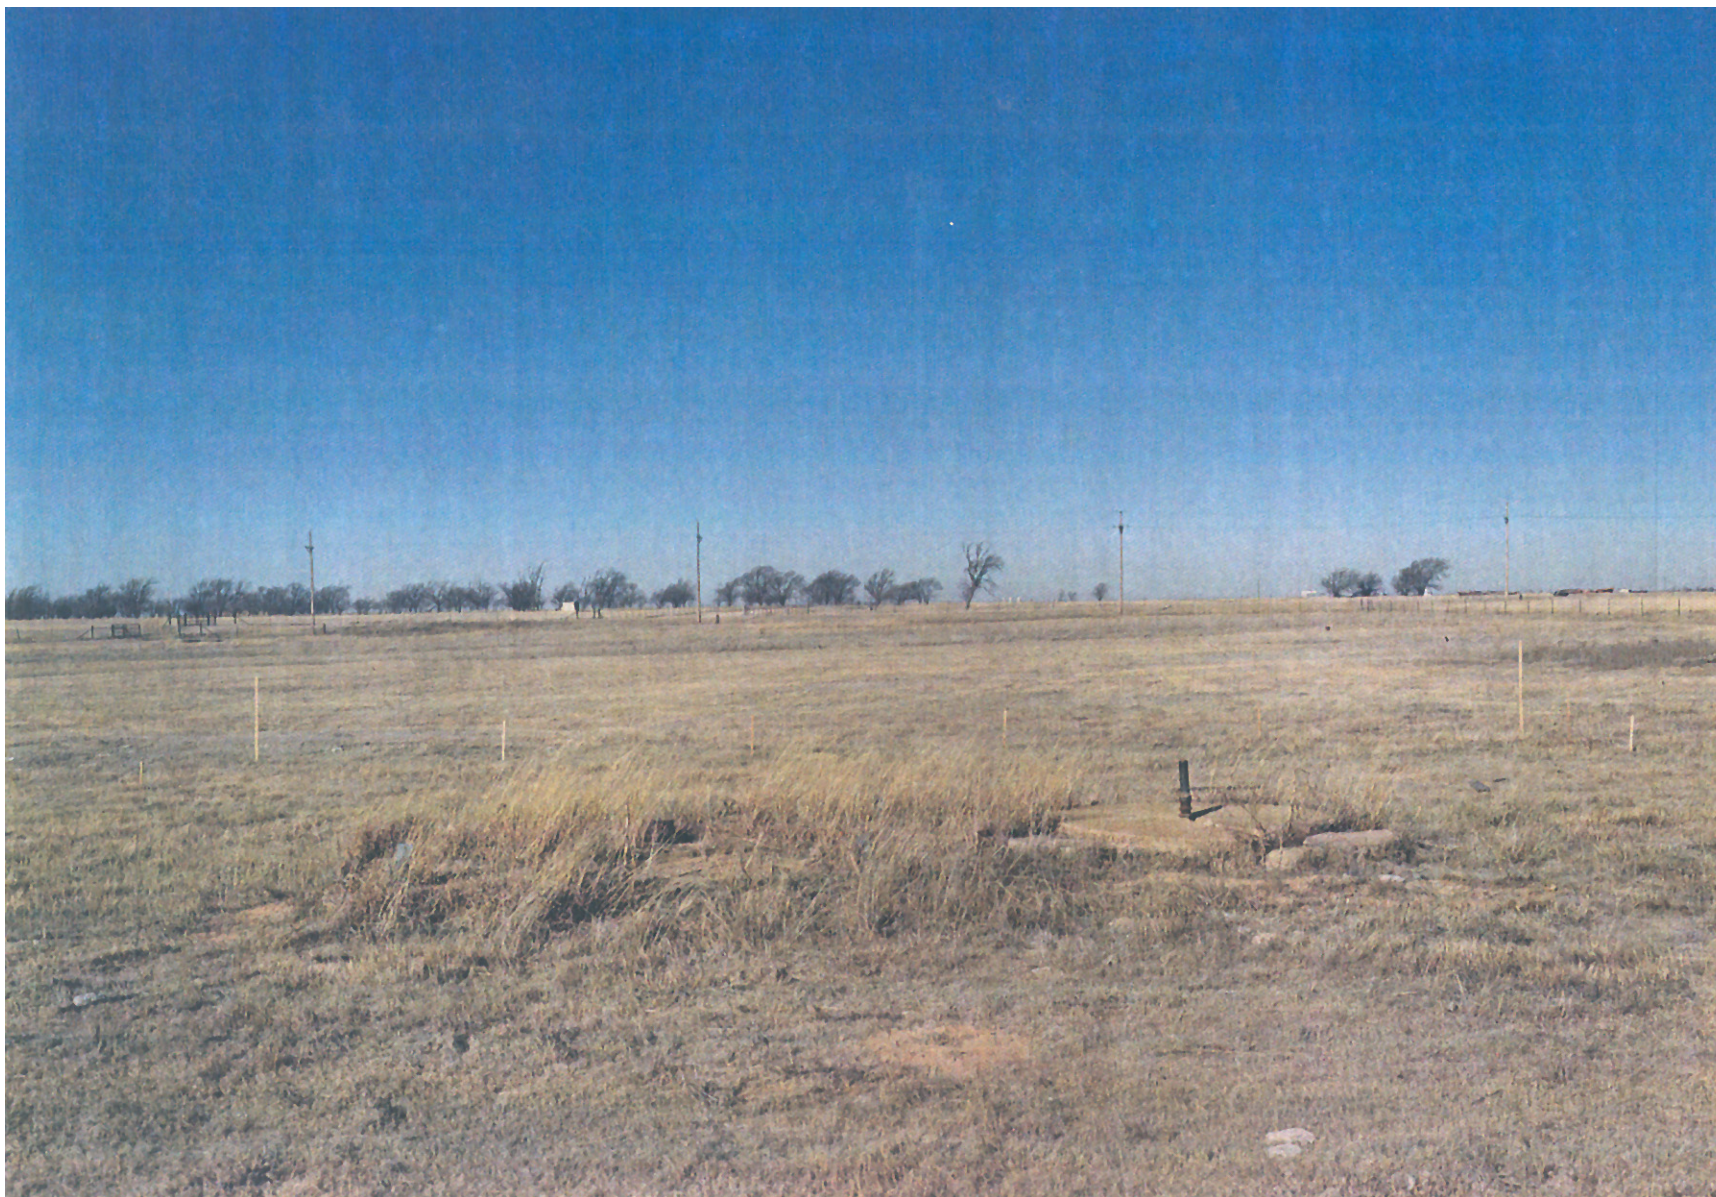
Figure 12. Well at homestead site HL-17, former Pantex Ordnance Plant and Texas Tech Research Farm near Amarillo, Texas. Photograph by John S. Ebling.
